HOUSATONIC RIVER BASIN  
MONTEREY, MASSACHUSETTS

LAKE GARFIELD DAM  
MA 00249

PHASE I INSPECTION REPORT  
NATIONAL DAM INSPECTION PROGRAM

MARCH 1980

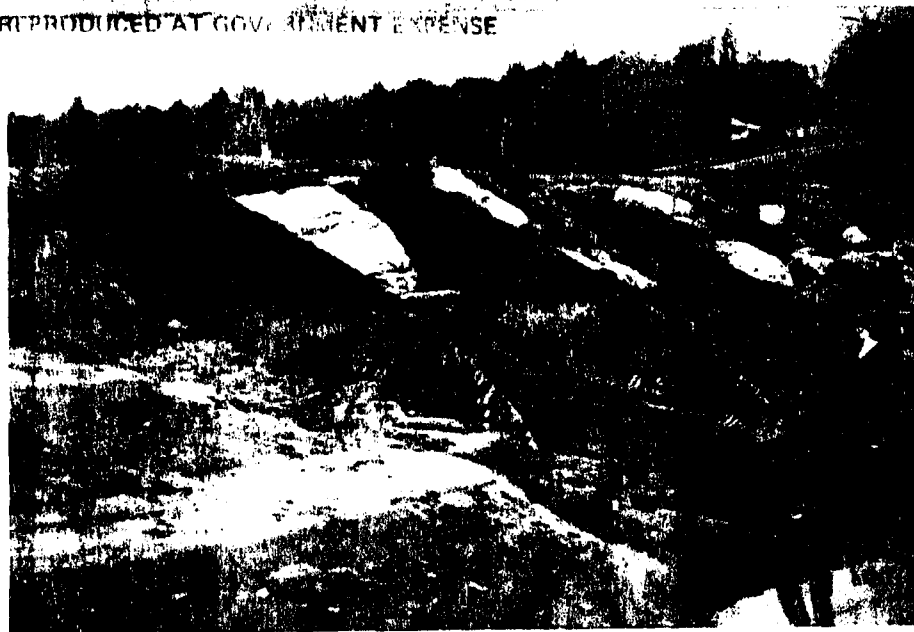
15

side of triple barrel  
 arch under Tyringham  
 which crosses impound-  
 ment area.

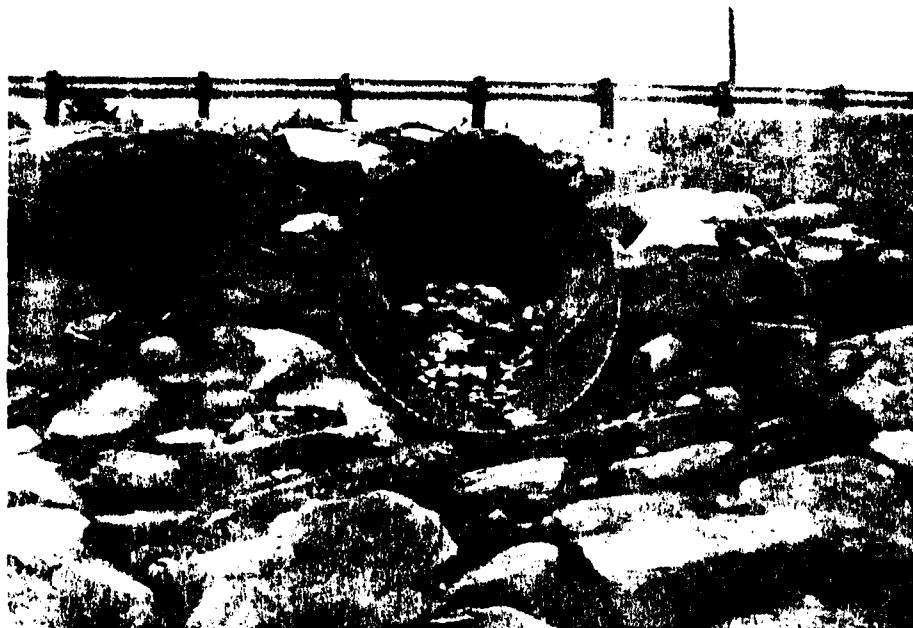
16

side of triple barrel  
 arch showing typical  
 accumulation.

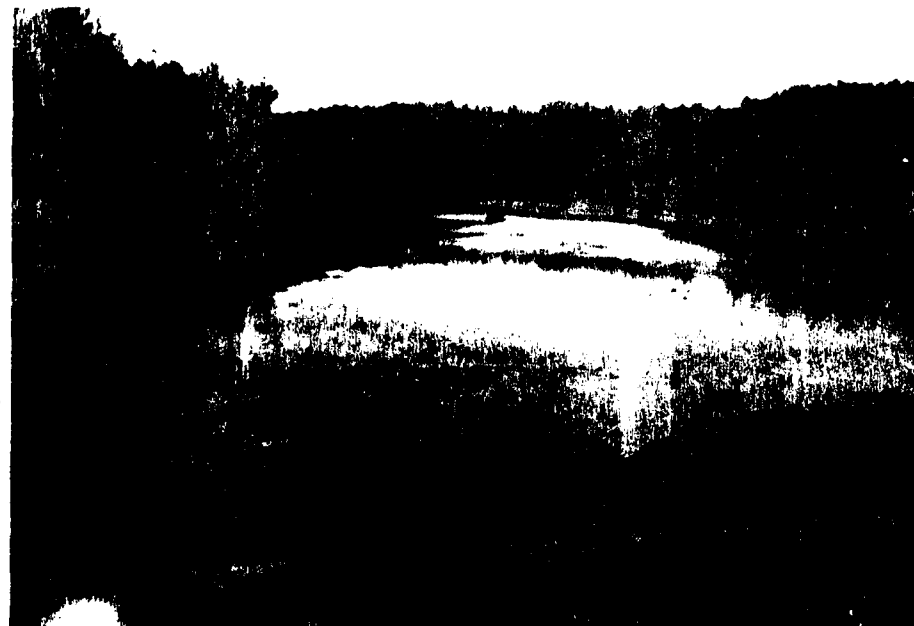
17

adjacent area looking  
 down of Tyringham Road  
 cuts towards dam  
 tion. (dam not in photo)

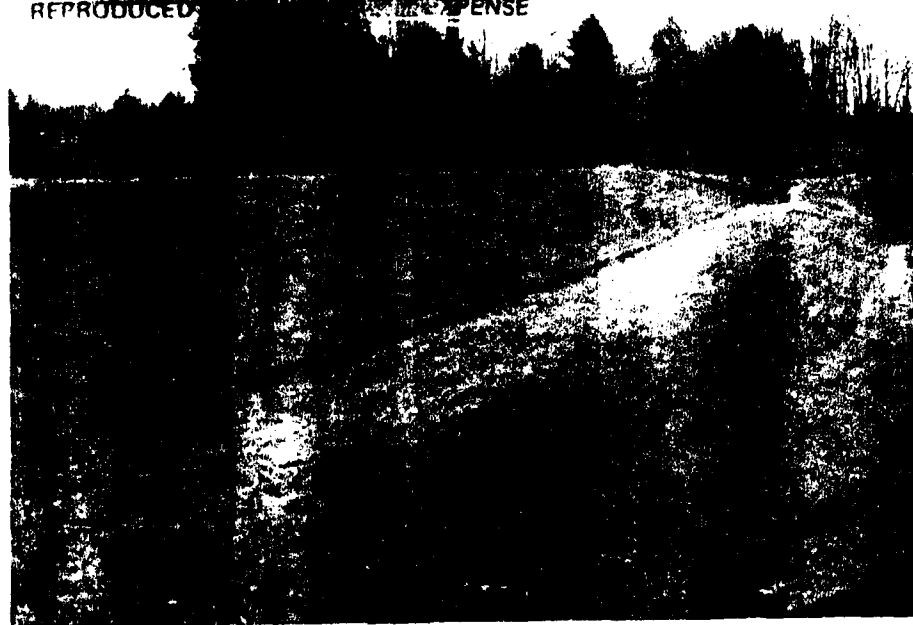
photo 4

downstream embankment  
sloping towards left  
attest from right  
side.
